Two-dimensional analysis of a drive sprocket mounting to a shaft using boundary element methods

*Richard E. Dippery, Jr.⁽¹⁾, C.V. White⁽²⁾, J. Ellis⁽¹⁾
Kettering University
Flint, Michigan USA*

Abstract

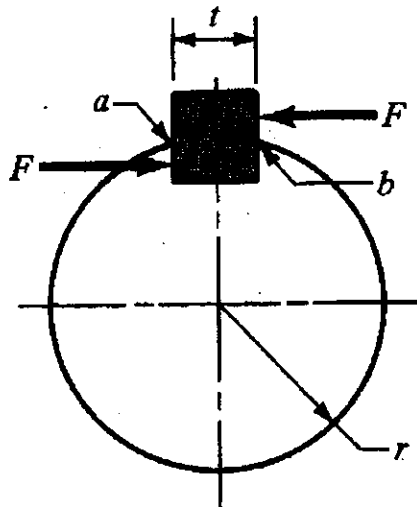
Stress analysis of keys is accomplished, again, through the use of “cookbook” type equations, obtained from texts such as Shigley [5], can be used to analyze the key. Referring to Figure 2 (a square key) for an applied torque(T), key of length(l), thickness (t), and shaft diameter (d), the resultant shearing force(F), shear (τ) and bearing (σ) stresses are:

Figure 2 - Forces acting on Key

$$F = \frac{T}{d/2}$$

$$\tau = \frac{F}{tl}$$

$$\sigma = \frac{F}{tl/2}$$

These equations allow for evaluation of the key for shear and bearing (i.e., crushing of the key) stresses. Evaluation of the shaft or other components is accomplished by other means such as localized stress analysis of the shaft and sprocket or gear.

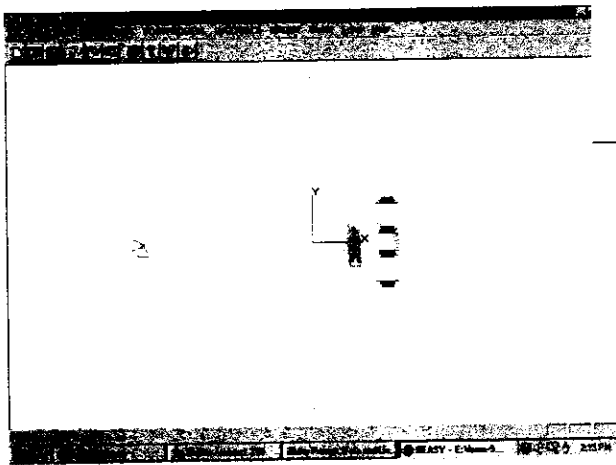
As previously mentioned, it was decided to initiate the evaluation using a two-dimensional model to gain insight into the effect of the key and its possible effect upon the failure of the device. With the absence of the key, and based upon some evidence the key may have been pressed (forced) into the slot, Figure 5, the BEASY model assumed a 5-mil interference fit on each side. The model is shown by Figure 6a. Solid modeling problems (generation of IGES files) negated modeling the teeth. A 100-pound load was therefore applied at the pitch diameter of the teeth. Later modeling will include the teeth. A square key was used with the edge held rigid as shown in Figure 6b.

Figure 6a - 2D Model

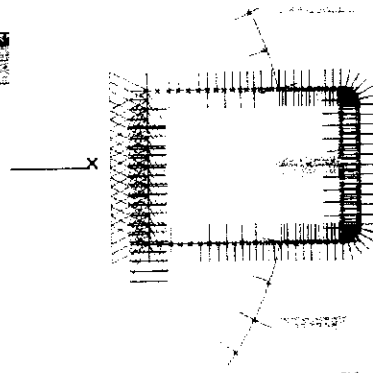
Figure 6b - Key Slot

The interference fit between the key and slot was modeled using gap elements (LINE_STRESS_BC, INITIAL_GAP).

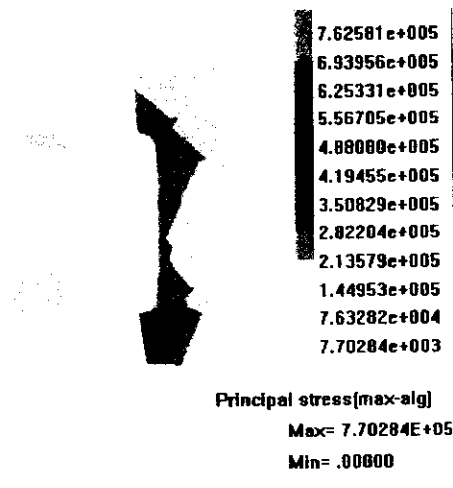
Results from the model are shown by Figures 7a, 7b, and 7c. Maximum stresses are in the range of 300-500 ksi, far exceeding the ultimate strength of the sprocket, assumed to be 80-ksi, based upon the hardness of the material. Hand calculations were performed assuming an interference fit of 0.0005 (one-half mil) on either side. When scaled, the analytical model and classical (hand) calculations are in agreement, with an average bearing stress of approximately 65 ksi. The hand calculations assumed both the key and sprocket had the same structural stiffness, which in reality is not true. Hence, the BEASY model correlates well with classical methods.

Figure 7a - Maximum Principal Stress

The two-dimensional model correlates well with classical calculations; and, with further development into a three-dimensional model provide accurate insight into the cause of failure. This in turn will provide information for corrective action to be taken in future designs, more likely, though, maintenance and operating practices to be used with the device.
